Subj: COMMAND INVESTIGATION INTO THE FACTS AND CIRCUMSTANCES
SURROUNDING THE FIRE ONBOARD USS BONHOMME RICHARD (LHD 6) ON
OR ABOUT 12 JULY 2020

**INTO THE FIRE ABOARD
USS BONHOMME RICHARD (LHD-6)
12 JULY 2020**

5830
Memo N00/156
5 Apr 21

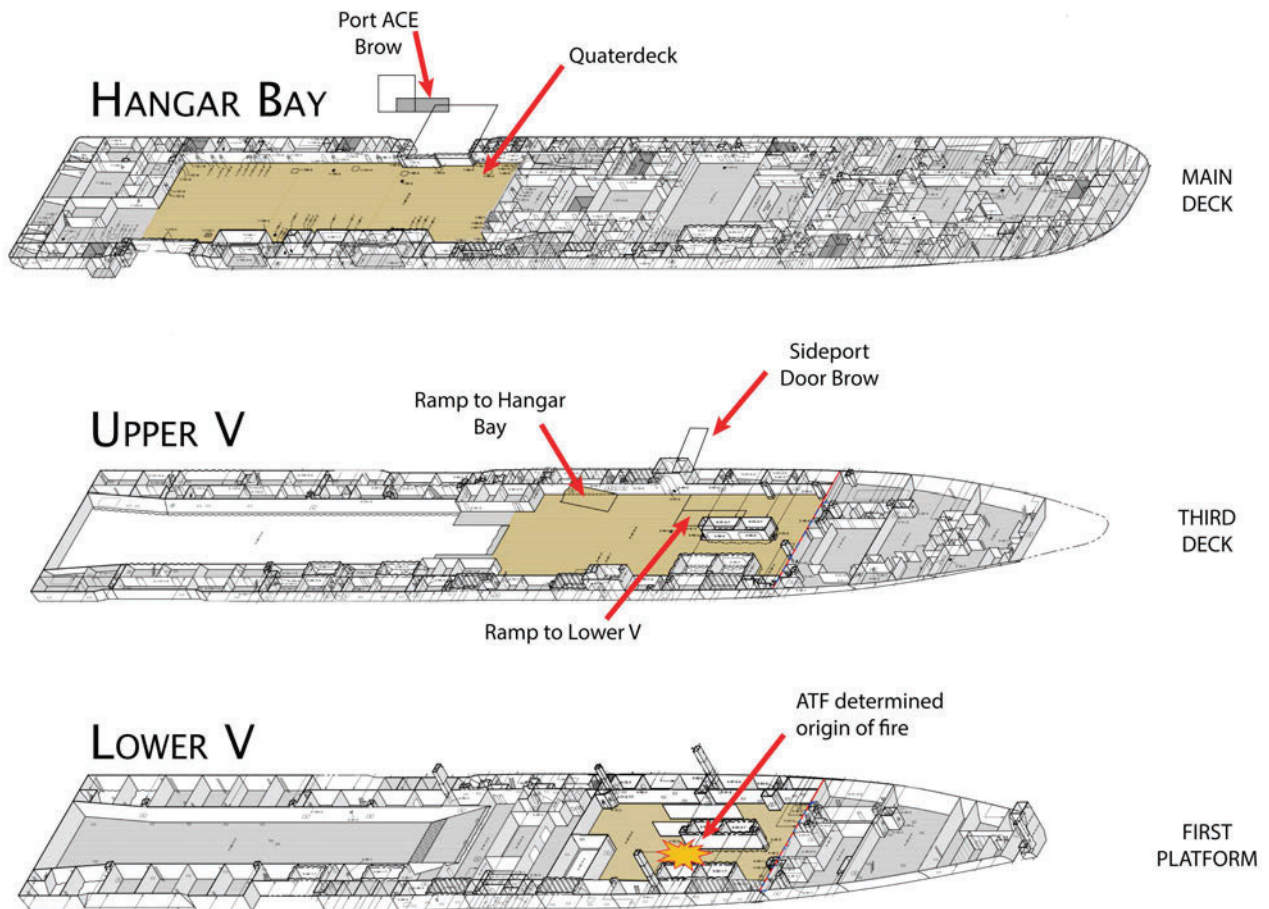
Figure 2 depicts various BONHOMME RICHARD decks and compartments.

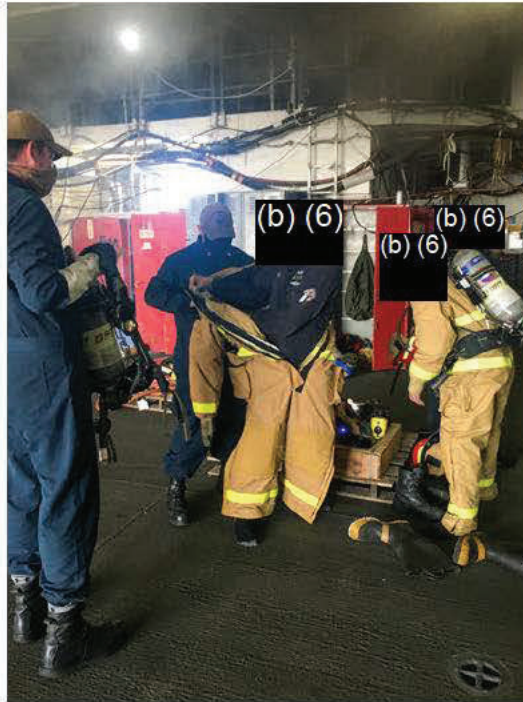
25. Following the 1MC announcement from the Quarterdeck, BONHOMME RICHARD Sailors began assembling in the Hangar and dressing out in SCBAs and Firefighting Ensembles (FFEs). Multiple Sailors, including several Chief Petty Officers (CPO), reported they did not dress out in FFEs because they were wearing the Type III Navy Working Uniform (NWU), rather than coveralls. The choice not to dress out was at least partially based on an assumption that it is not

Figure 3 captures BONHOMME RICHARD Sailors dressing out in the Hangar.

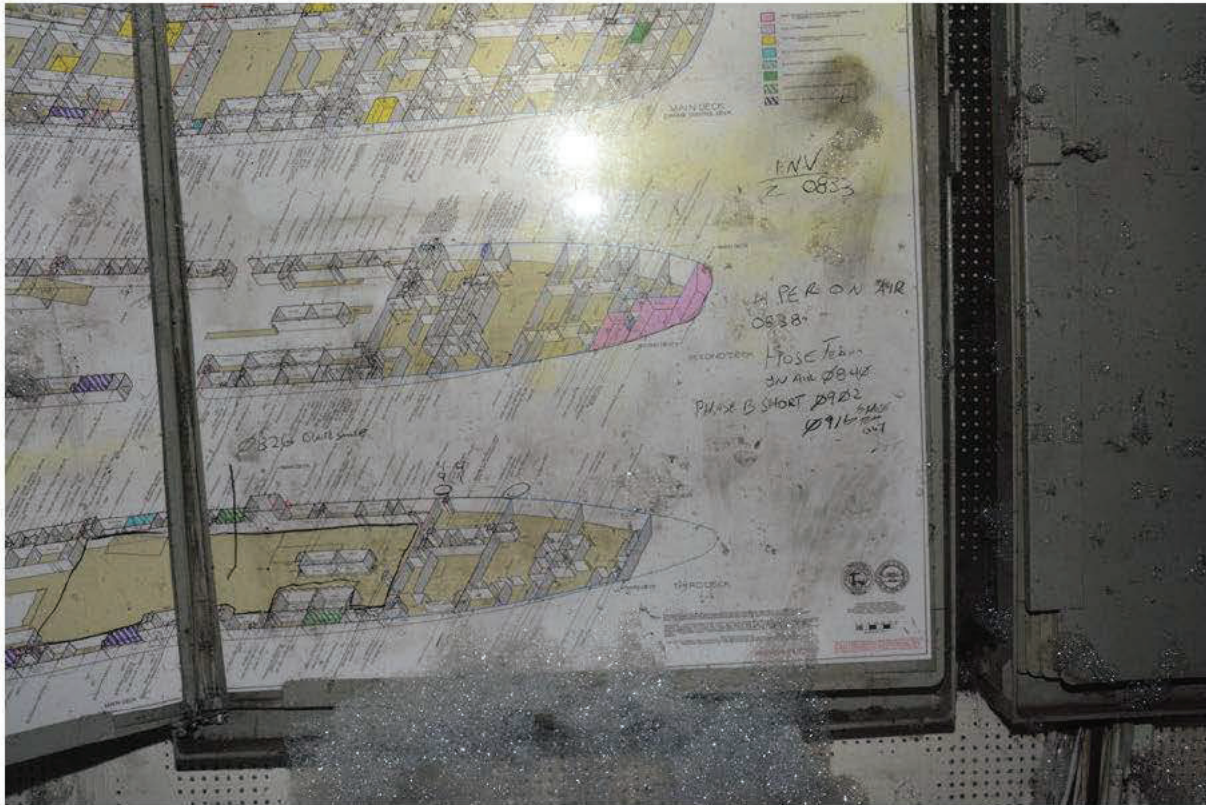
35. DC Central DC plates indicate that at 0838, a four-man team went donned SCBAs and went on air. At 0840, the DC Central DC plates indicate that a hose team went on air. In handwritten notes, the EDO also logged a six-man team on air at 0904. (See Figure 4, which depicts the BONHOMME RICHARD DC plates in DC Central). [Encl 69]

Figure 4 depicts the BONHOMME RICHARD DC plates in DC Central.

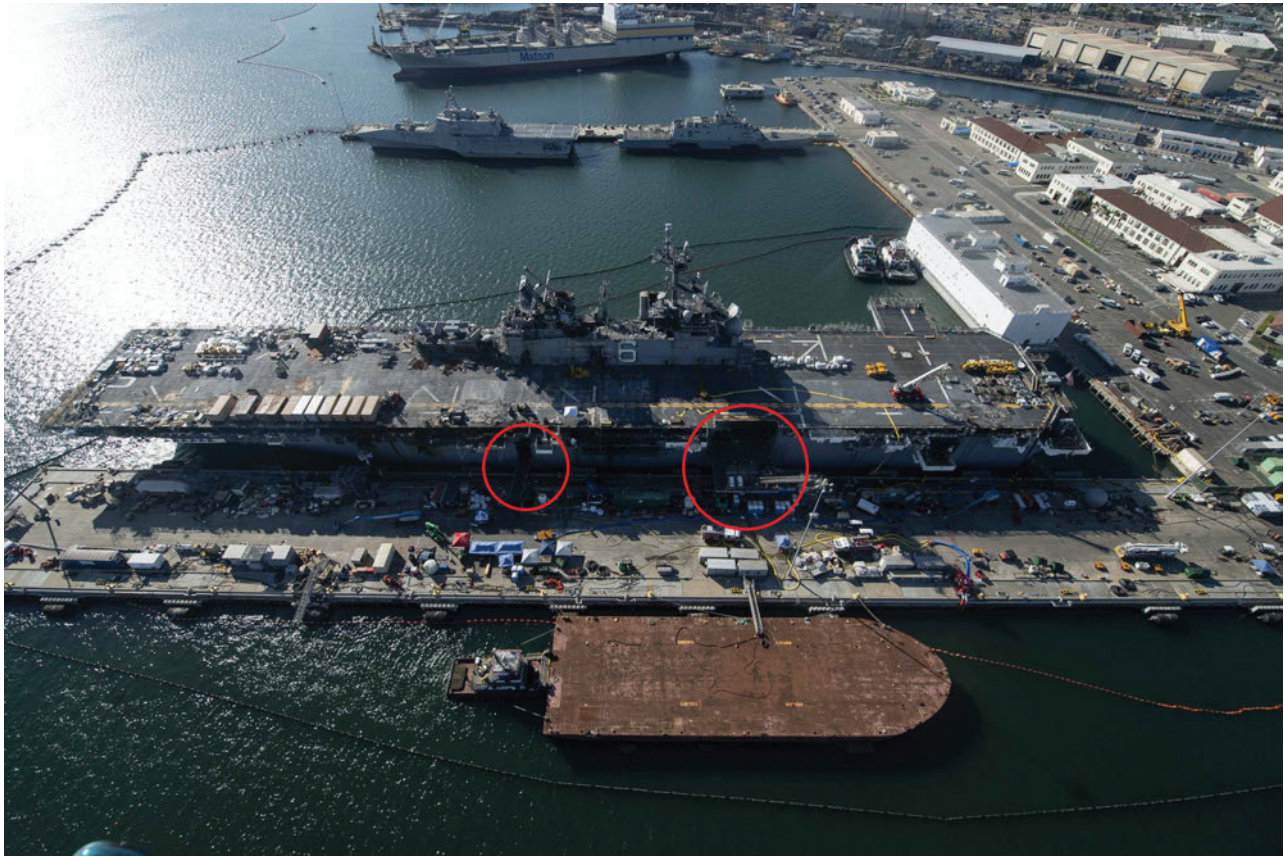
Figure 5 is a photograph of BONHOMME RICHARD with the sideport door/port ACE identified.

49. FEDFIRE proceeded to establish its attack via the port ACE (See Figure 5 above) and commenced running hoses from its engines on the pier up to the port ACE. With no installed firemain system on Pier 2 (or any other NBSD pier), FEDFIRE Engine 161 connected to the potable water riser, which was supplying water to FITZGERALD located on Pier 2. Once established in the Hangar, FEDFIRE ran hoses through the forward portion of the Hangar, down the Upper V ramp, through Upper V, and down the ramp to Lower V. Engine 161, led by FEDFIRE (b) (6), was the first team to lay a hose line down to Lower V. His team consisted of four FEDFIRE firefighters and (b) (6). FEDFIRE Engine 161 laid 200 feet of hose from the Quarterdeck, across the Hangar, down the Upper V ramp, and across Lower V. They then had to attach an additional 100 feet down the ramp. After laying this hose, FEDFIRE Engine 161 was not able to combat the fire because a team member received a “low air” alarm on his SCBA. FEDFIRE (b) (6)’s team egressed at approximately 0904. [Encl 44, 126, 140, 148, 149, 151, 152, 153, 154, 155]

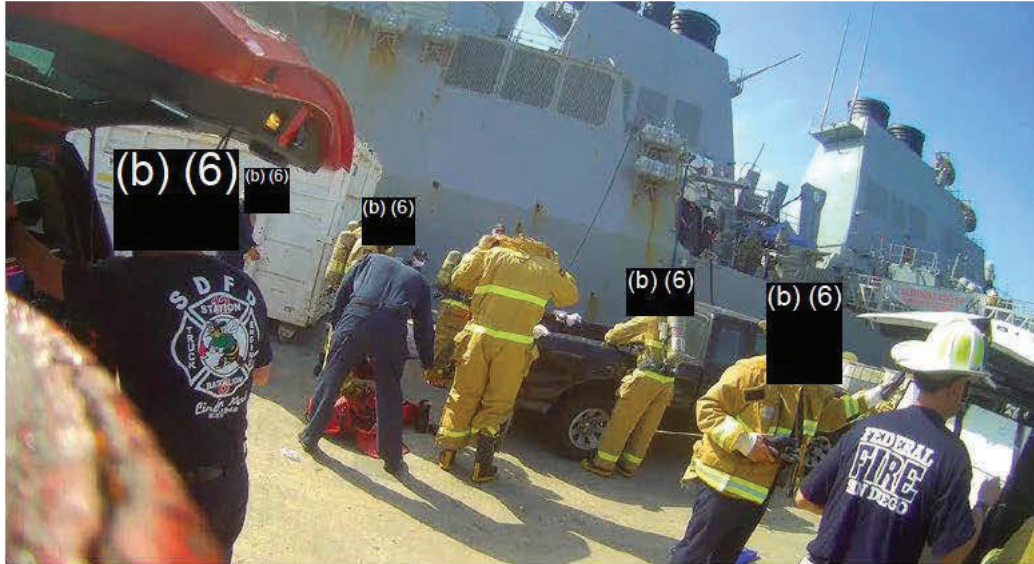
Figure 6 is a screen capture from SDFD (b) (6)'s helmet-mounted camera footage. The image shows the ICP (FEDFIRE and SDFD command vehicles with tailgates up) at approximately 0910.

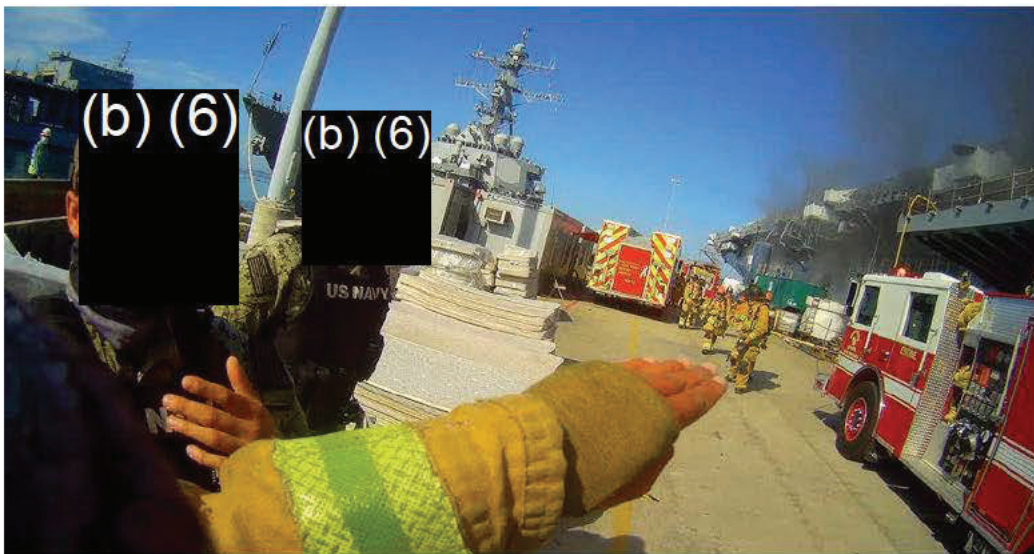
59. After arriving at 0900 and checking in with FEDFIRE (b) (6) near the entrance to Pier 2, SDFD (b) (6) walked down the pier and asked a Navy Sailor whether he knew where the fire was located. The Sailor replied that the fire was located either in Upper V or Lower V while pointing past the port ACE toward the sideport ramp. SDFD (b) (6) asked several personnel for a "map" of the ship but was unable to acquire one. [Encl 126, 166, 180]

Figure 7 is a screen capture from SDFD (b) (6)'s helmet-mounted camera footage. At approximately 0908, SDFD (b) (6) stopped Sailors to seek information about the fire.

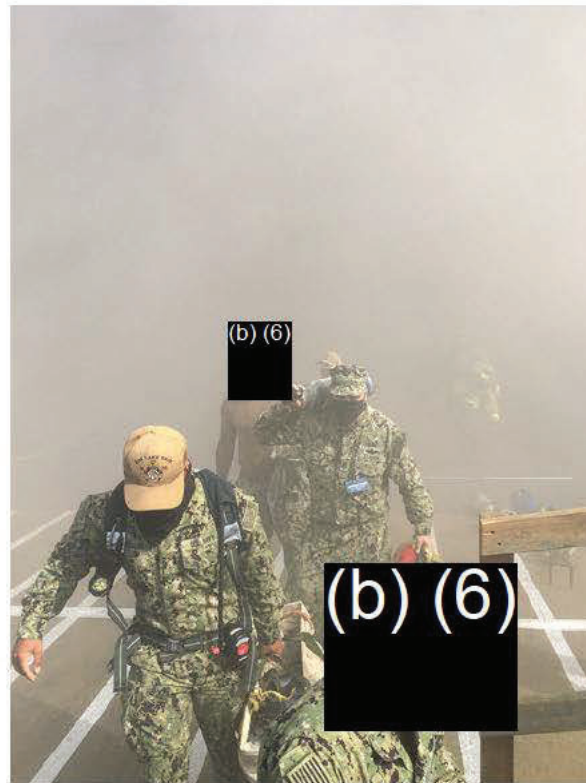
65. At approximately 0900, (b) (6) and RUSSELL's R&A team were directed to evacuate the Hangar due to smoke. They debarked and staged on the pier next to the sideport ramp. RUSSELL's team observed numerous BONHOMME RICHARD Sailors departing the ship. At approximately 0915, due to deteriorating smoke conditions in the Hangar, the CDO ordered all personnel not wearing SCBAs to evacuate the ship. Prior to issuing this order, the CDO spoke to BONHOMME RICHARD CO via phone and informed him that he (the CDO) was ordering the evacuation of non-SCBA wearing personnel. The CO concurred with this action and ordered the evacuation. There are varying reports on whether this evacuation order was communicated over the 1MC. [Encl 27, 41, 70, 98, 99, 142, 185, 195]

Figure 9 shows Sailors evacuating the BONHOMME RICHARD Hangar.

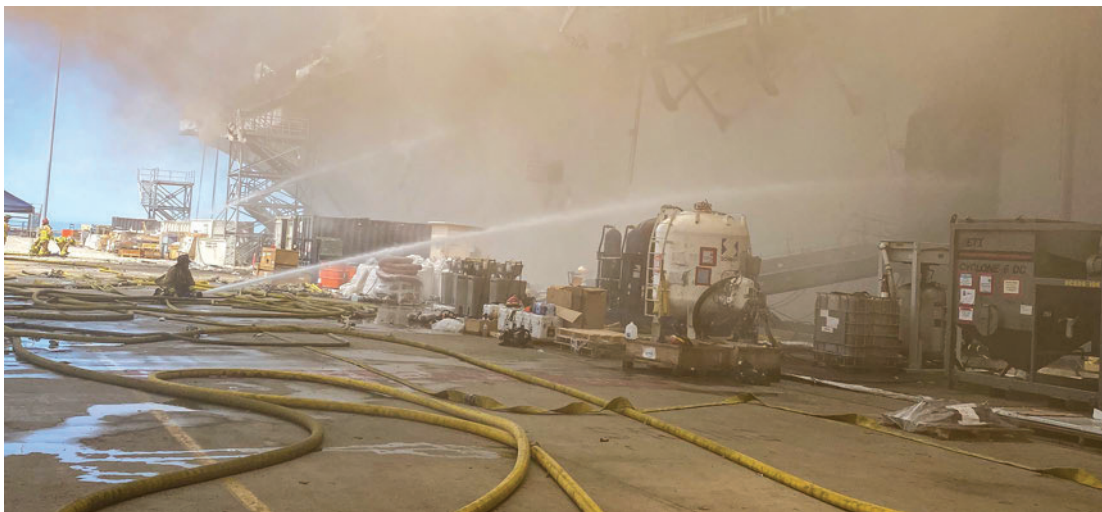
101. At approximately 1124, FEDFIRE personnel and several BONHOMME RICHARD Sailors, including the DCA, returned to Pier 2 to establish an unmanned monitor (fire nozzle) at the sideport door, which sprayed water directly into Upper V from the sideport door. FEDFIRE (b) (6) and FEDFIRE (b) (6) were the first FEDFIRE firefighters to return to the pier after the explosion. FEDFIRE (b) (6)’s team was tasked with leading a firefighting effort up to the Hangar (Division 1) while FEDFIRE (b) (6)’s team was tasked with leading a firefighting effort into Lower V (Division 2). Due to the intensity of the fire, Divisions 1 and 2 were re-tasked with evaluating the state of the fire and determining the feasibility of recommencing firefighting efforts. The fire’s intensity, heat, and a significant amount of debris forced the divisions to use a “round robin” approach to combatting the casualty. The teams departed just outside the ship and swapped out bottles before reentering and continuing to fight. [Encl 149, 189, 203, 257, 258, 259]

Figure 13 shows firefighting monitors spraying water from the pier on 12 July 2020.

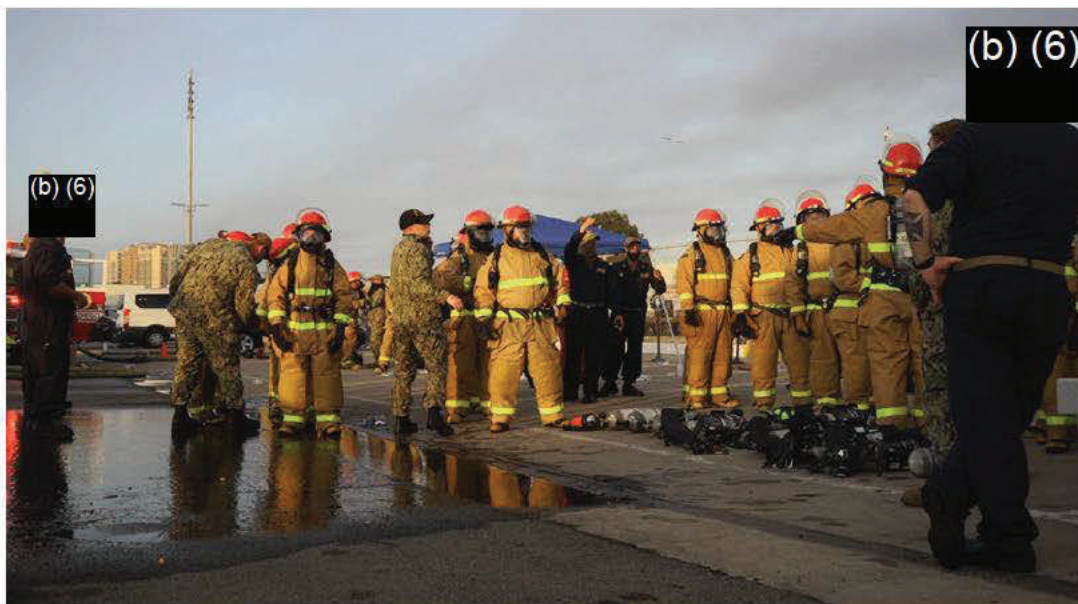
152. Expanding beyond the initial early efforts of a few Sailors, over the remainder of the afternoon, teams of BONHOMME RICHARD Sailors began joining FEDFIRE in firefighting efforts. Initially, BONHOMME RICHARD teams were not integrated with FEDFIRE teams; while both organizations contributed teams, the teams themselves were not integrated. A team of BONHOMME RICHARD Sailors entered via the sideport door at approximately 1530. By this time, two unmanned monitors, each capable of deploying 300 gallons-per-minute (GPM), were placed in Upper V with one pointing in Upper V itself and the second pointing down the Lower V ramp. Despite issues with water volume, these monitors continued pumping water into Upper and Lower V. [Encl 149, 172, 197, 249, 313, 380, 381]

Figure 14 shows BONHOMME RICHARD Sailors organizing into fire teams.

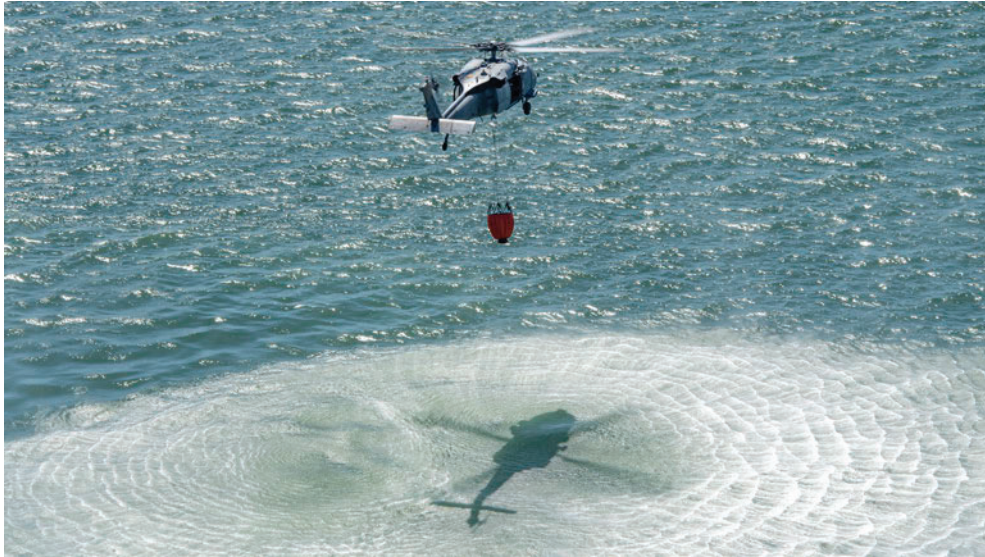
172. From 12 July 2020 until 15 July 2020, 1,649 water drops were conducted, deploying 545,076 gallons of water. (See Figures 16 and 17). After 12 July 2020, the SCORE detachment was augmented by additional aircrews from HSC-3. Various Navy, FEDFIRE, and contract firefighting personnel disagreed about the overall effectiveness of the water drops. [Encl 188, 308, 391, 393, 394, 395]

Figure 16 shows a SH-60 helicopter picking up water to conduct water drops on BONHOMME RICHARD.

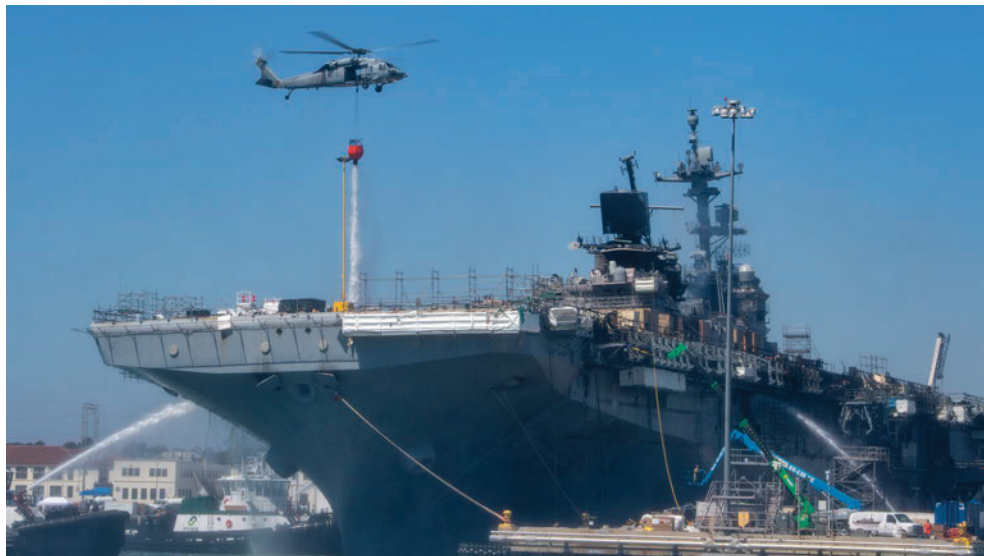
Figure 17 shows a helicopter conducting a water drop on BONHOMME RICHARD.

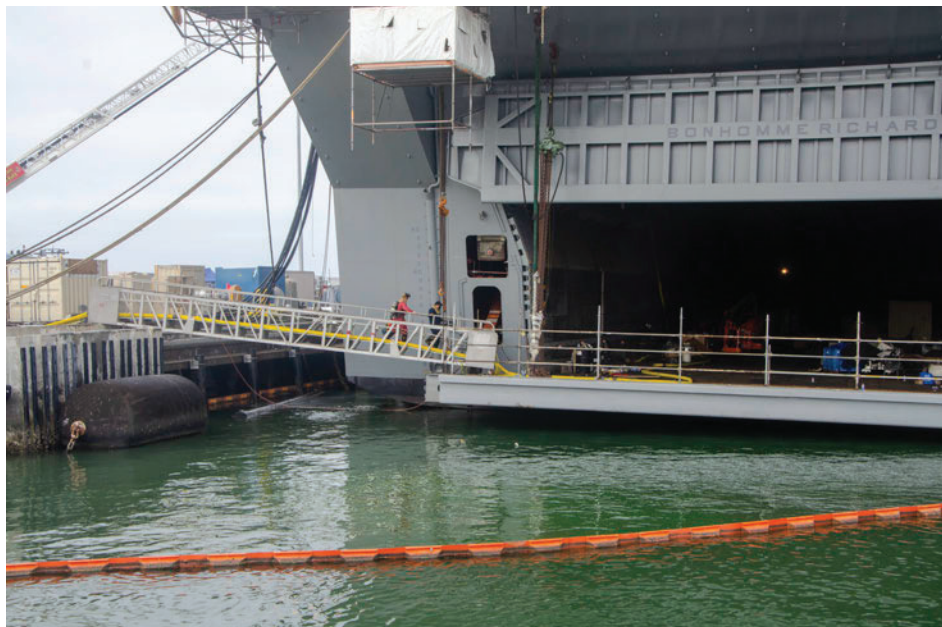
175. At approximately 0211, 13 July 2020 a NAVFAC crane, organized by (b) (6), landed a brow on the stern gate, enabling a 20-man hose team to enter and relieve the 5-man team. (See Figure 18). This team continued the fire attack by advancing forward through the Well Deck toward Upper V. [Encl 72, 179, 187, 249, 313, 385, 396, 397, 398]

Figure 18 shows the stern gate brow, which was landed at approximately 0211 on 13 July 2020.

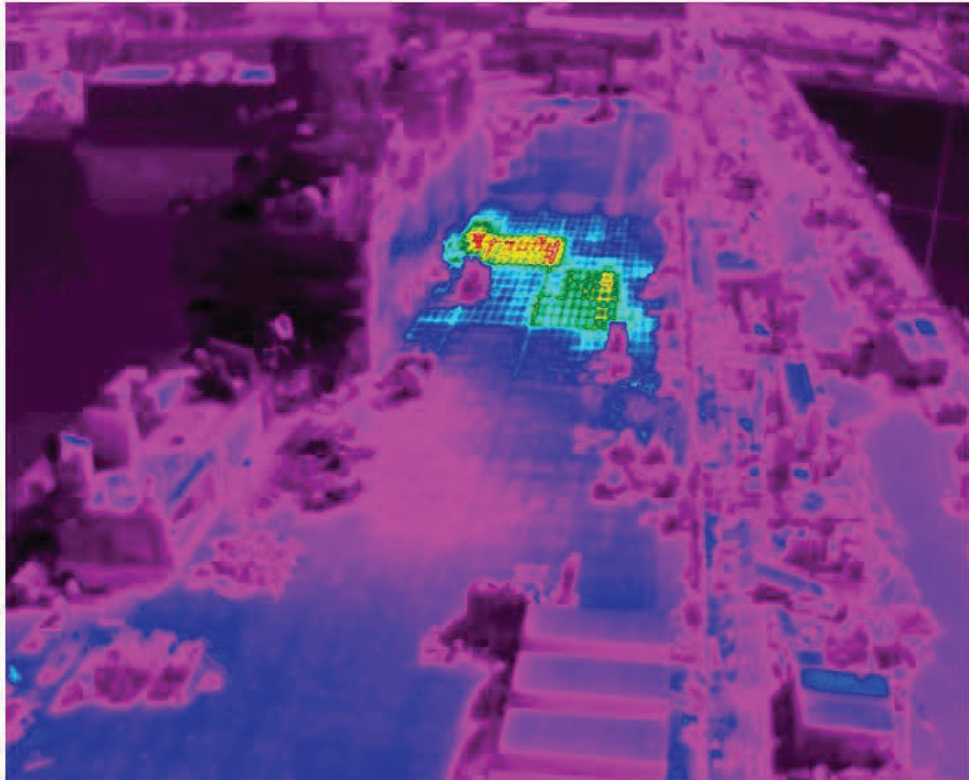
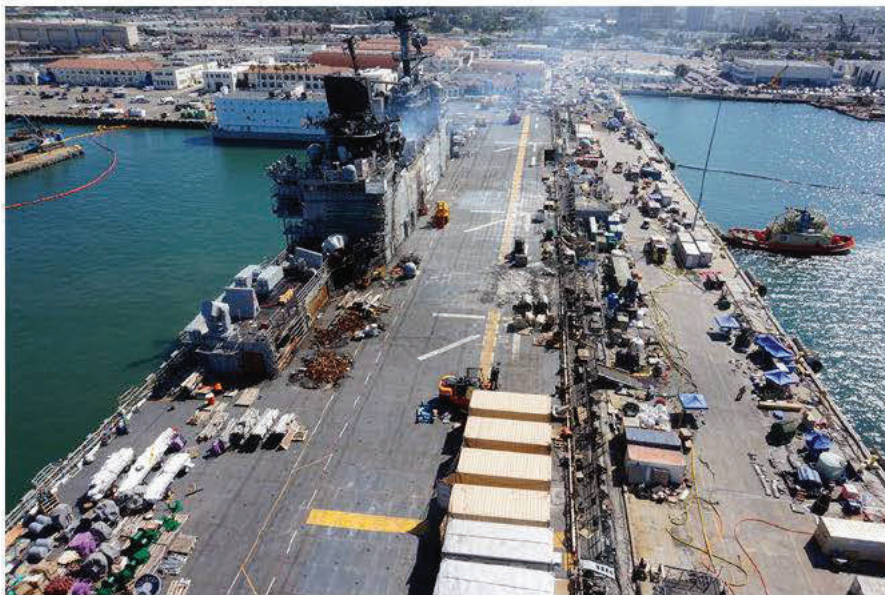
NBSD approval. This drone was subsequently used to identify hot spots for targeted firefighting efforts. US Fire Pump recommended cutting targeted holes in the ship to gain access to compartments with excessive heat or active fire. The first cuts started later that day at approximately 1737. [Encl 34, 141, 249, 314, 392, 394, 407, 409, 410, 411, 412, 413]

Figure 19 show US Fire Pump forward-looking infrared (FLIR) imagery of BONHOMME RICHARD, compared to a standard photograph taken simultaneously by the same drone.

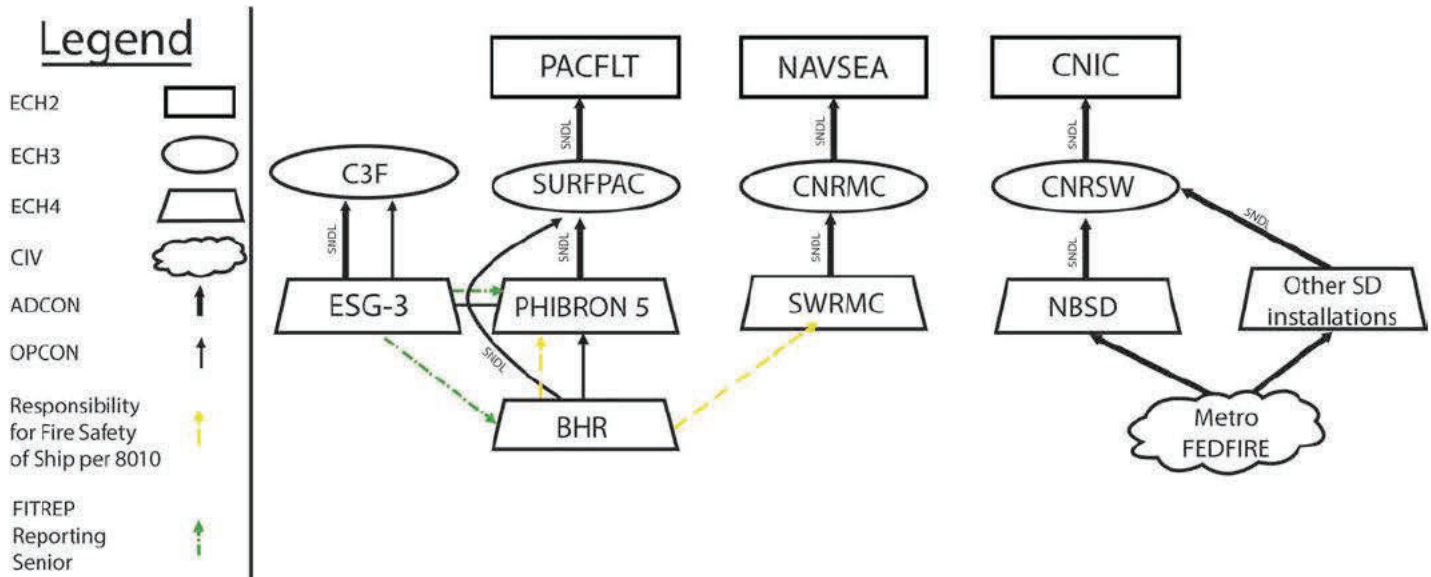
Figure 20 depicts the various command and supporting relationships related to BONHOMME RICHARD fire safety during its availability.

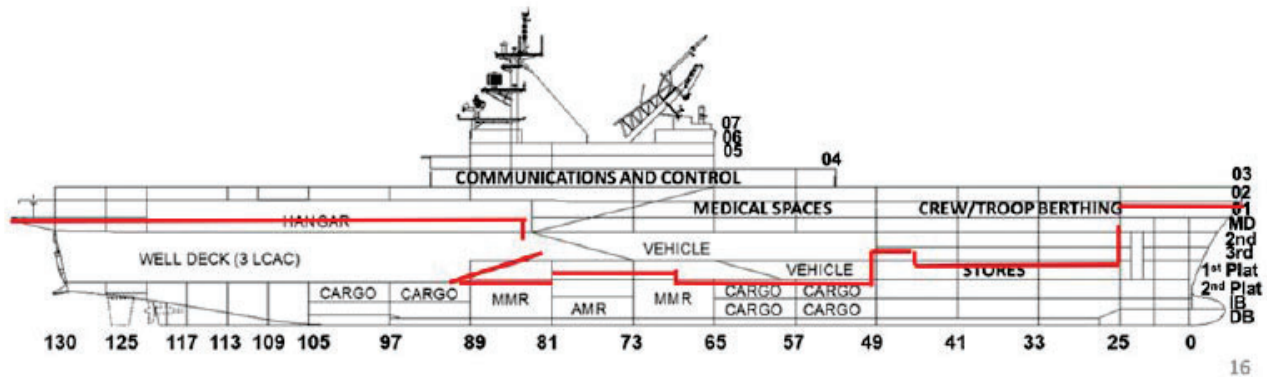
Figure 46 shows the NAVSEA “cut-line.”

1046. To aid in repair calculations, the MA established an approximate “cut-line,” above which virtually no compartment is salvageable. The MA concluded that restoration above the cut-line would entail the removal and replacement of entire decks, compartments, and all associated contents and equipment. Major spaces above the cut-line include: the island structure, all 02-level compartments for the entire length of the ship, all 01-level compartments from Frame 25 to the stern, all compartments on the Main Deck from Frames 25 to 89. Key spaces below the cut-line that still require total replacement include Damage Control (DC) Central (5-79-0-C, Ship’s Laundry (4-73-0-Q), Upper Vehicle Stowage Area (Upper V) (3-49-0-A) and Lower V (4-49-0-A). [Encl 731]

1047. Below the cut-line, the MA concluded that most compartments are either intact or could be repaired via standard ship repair processes. Major spaces below the cut-line include: 1 Main Machinery Room (MMR) (6-65-0-E), 2 MMR (6-81-0-E), Auxiliary Machinery Room (AMR) (6-73-0-E), Lower Cargo Ammunition Magazines (6-49-0-M, 6-57-0-M), Aft Steering (7-121-2-
